DEPARTMENT OF TRANSPORTATION

Quality Assurance and Source Inspection

Contract #: 04-0120F4Cty: SF/ALA Rte: 80 PM: 13.2/13.9File #: 69.28**WELDING INSPECTION REPORT****Resident Engineer:**Pursell, Gary**Address:** 333 Burma Road**City:** Oakland, CA 94607**Report No:** WIR-000773**Date Inspected:** 15-Oct-2007**Project Name:** SAS Superstructure**OSM Arrival Time:** 630**Prime Contractor:** American Bridge/Fluor Enterprises, a JV**OSM Departure Time:** 1530**Contractor:** Zhenhua Port Machinery Company, Ltd (ZPMC), Changxing Island **Location:** Shanghai, China**CWI Name:** Lu Jian Hua**CWI Present:** Yes No**Inspected CWI report:** Yes No N/A**Rod Oven in Use:** Yes No N/A**Electrode to specification:** Yes No N/A**Weld Procedures Followed:** Yes No N/A**Qualified Welders:** Yes No N/A**Verified Joint Fit-up:** Yes No N/A**Approved Drawings:** Yes No N/A**Approved WPS:** Yes No N/A**Delayed / Cancelled:** Yes No N/A**Bridge No:** 34-0006**Component:** OBG weld trial**Summary of Items Observed:**

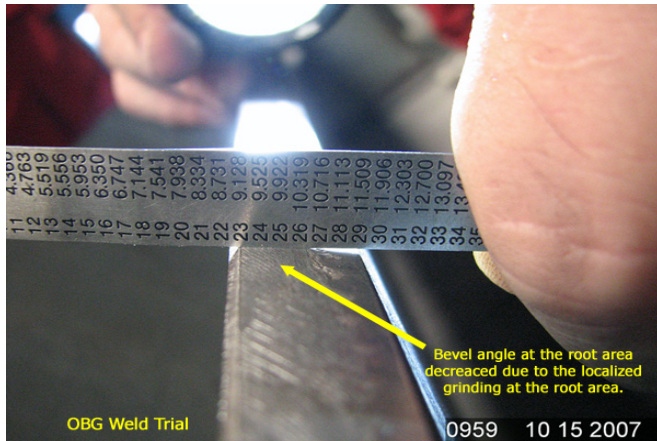
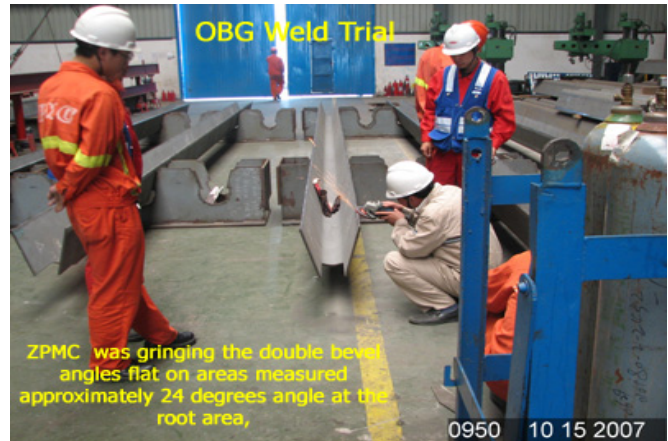
The QA inspector performed bevel angle verifications on the u-ribs U-70, U74, U-102,U-104 and U-71 for the OBG weld trial. The QA inspector took 22 measurements for every U-rib (110 total)at approximately 800 mm apart and approximately at the same location where ZPMC QC personnel measured the bevel angles. The QA inspector obtained bevel angles from 25 degrees and 45 minutes to a maximum of 28 degrees and 15 minutes and average bevel angle of 27 degrees. ZPMC results were similar to the results obtained by the QA inspector. However, there were several locations where the QA inspector observed that ZPMC ground the bevel with a dual angles (no flat). The photograph below shows one of the locations where the bevel angle was decreased at the root area. The QA inspector had a conversation with the ABF representatives Mr. Craig Knops and Mr. Art Peterson. The QA inspector brought to the attention to the ABF and ZPMC representatives about this issue. ZPMC agreed after rechecked the areas in question. ZPMC ground flat the areas where the bevel angles were reduced at the root areas. The photograph below shows ZPMC performing grinding operations on the surface of the bevels.
